**Summary Report  
Hydraulic Hoist Removal**

TOSCO Facility No. 256357  
3323 Marine View Drive  
Marysville, Washington  
SECOR International Incorporated  
Project No. 01TO.10614.01

**October 9, 2002**

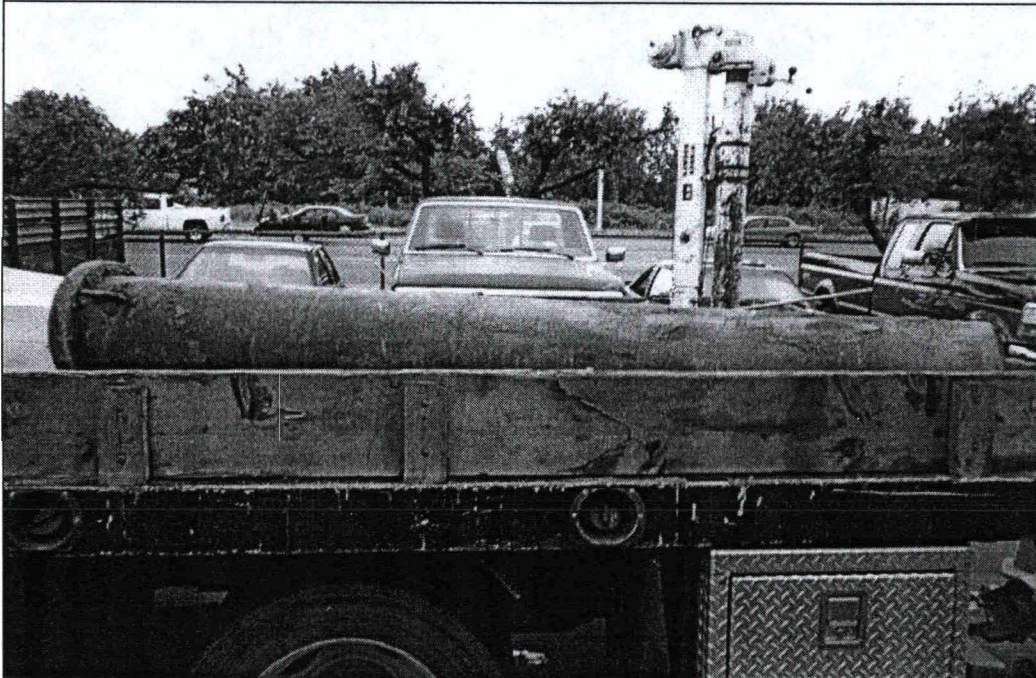
The in-ground hoist measured 16" in diameter and 96" in length. The hydraulic oil tank was contained within the body of the hoist. The removed hoist appeared to be in good condition, there were no visible cracks, holes, or signs of leakage.

Photograph 2: View of removed hydraulic hoist

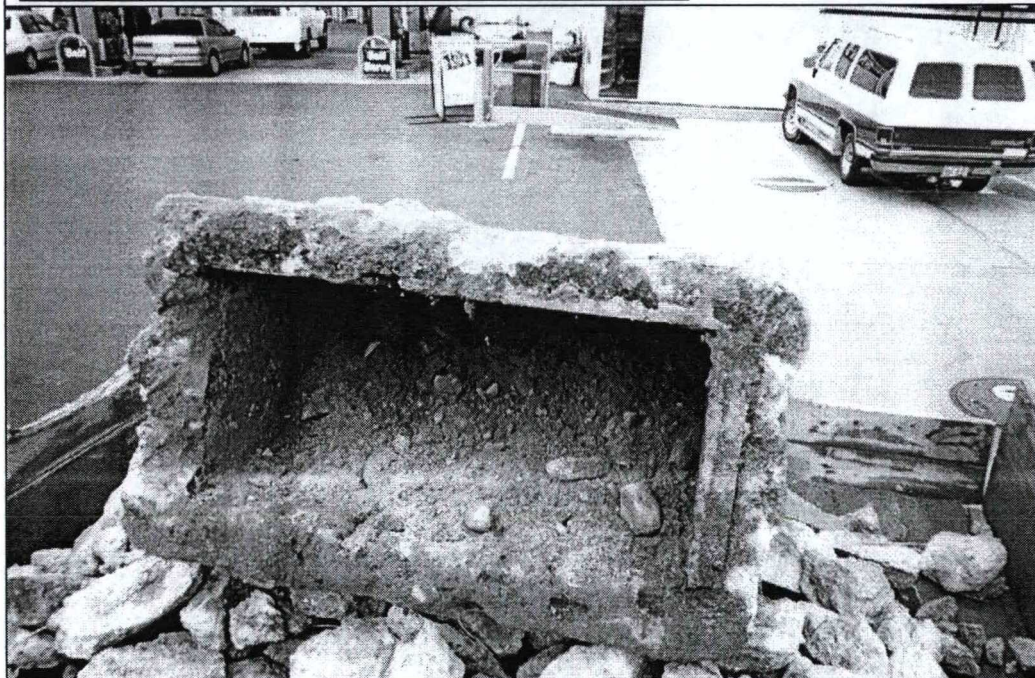
A concrete drain sump was also removed from the hoist excavation. The sump measured 2 feet in width by 3.5 feet in length by 3 feet in depth and was located just below the surface of the concrete overburden material. The sump appeared to be in good condition there were no visible cracks, holes, or signs of leakage.

Photograph 4: View of removed concrete drain sump.

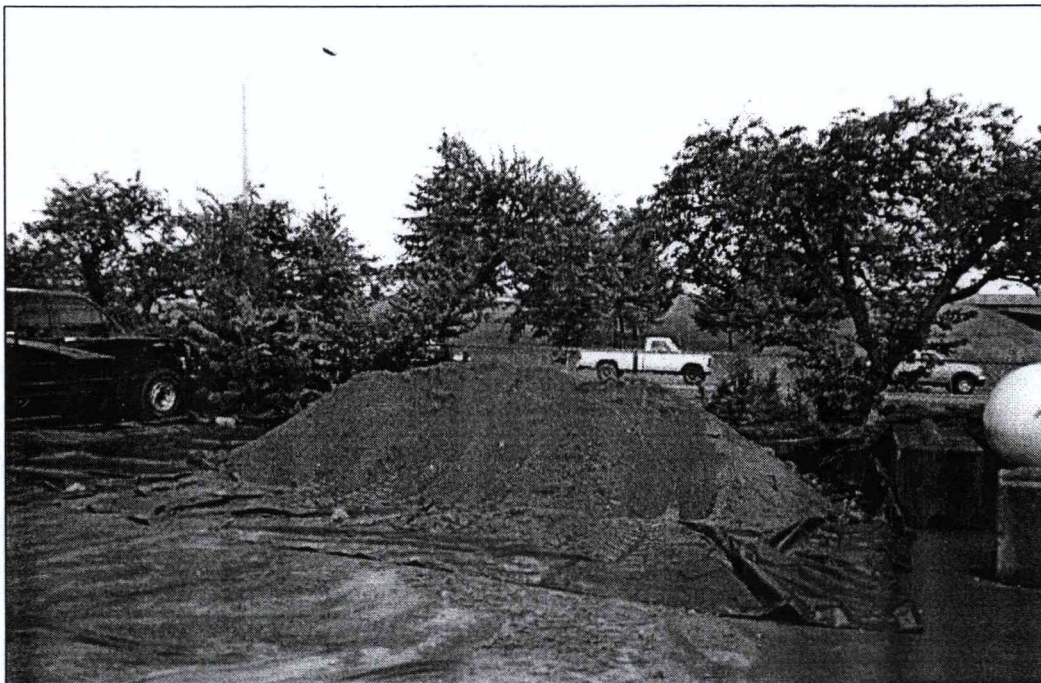
Pending laboratory analytical results, excavated soils were stockpiled on, and covered with, plastic sheeting. The stockpile was located southeast of the service building, in a paved parking area. The soil stockpile was approximately 25 cubic yards in volume.

Photograph 5: View of soil stockpile, SP1, looking east.

Based on TPH concentrations recorded in the stockpile sample, management of the stockpiled soils required adherence to the DOE document '*Guidance for the Remediation of Petroleum Contaminated Soils*'. SECOR contacted TPS Technologies Inc. (TPS) and arranged for the disposal of the stockpiled soils at a state-licensed facility. A copy of the waste disposal manifest is included as Attachment E.
